Meadow Vale Farm HOA
Co. Hwy 119 & Weld Co. Road #5.5
Longmont, CO 80504

Level 1 Reserve Analysis
Original Reserve Study with Property Inspection

Report Period – 06/01/05 – 05/31/06

Client Reference Number – 04072
Property Type – Detached Home Community
Number of Units – 88
Fiscal Year End – December 31

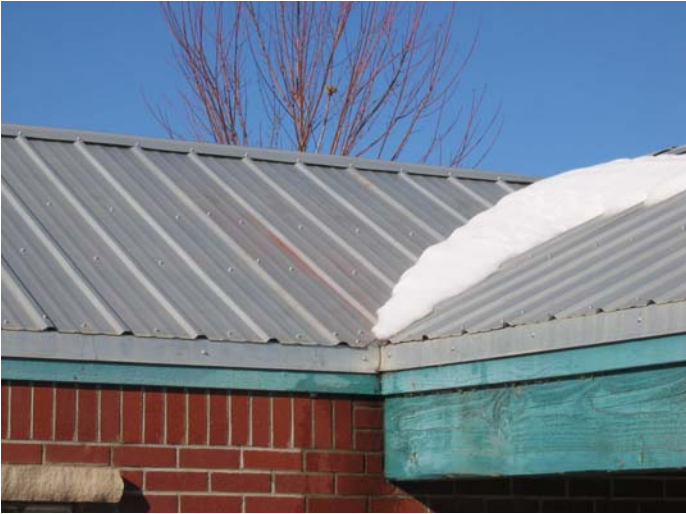
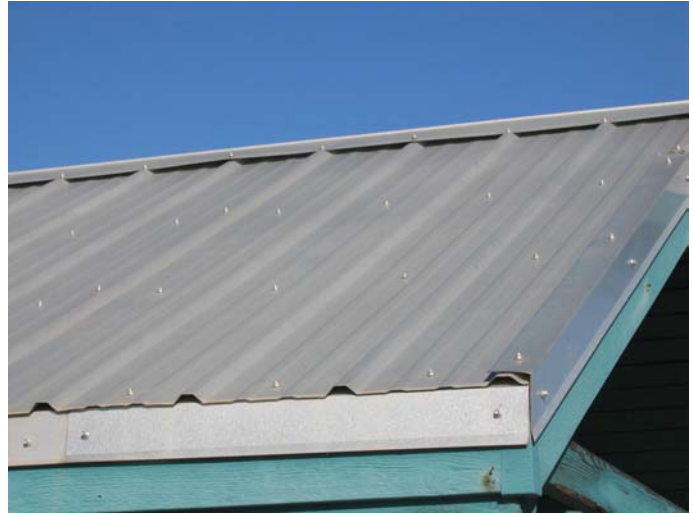
Comp #: 105 Metal Roof - Replace

No unusual conditions observed with this roof. Metal roofs have an extensive life expectancy under normal conditions and this material should not rust or corrode. Therefore, due to an extended replacement cycle, no Reserve funding is required at this time.

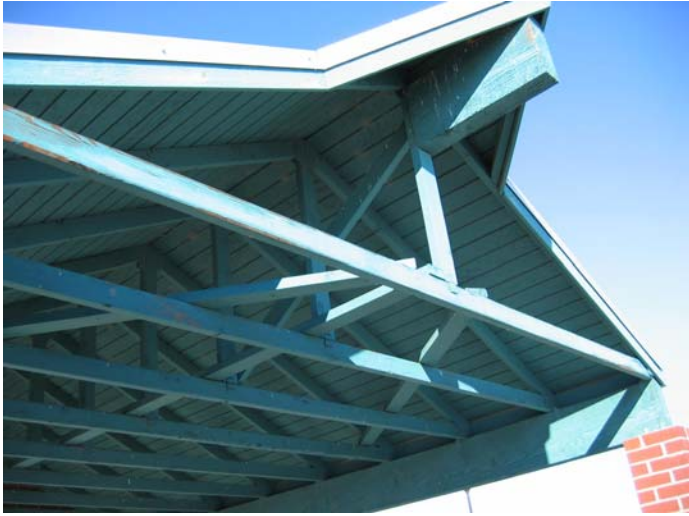
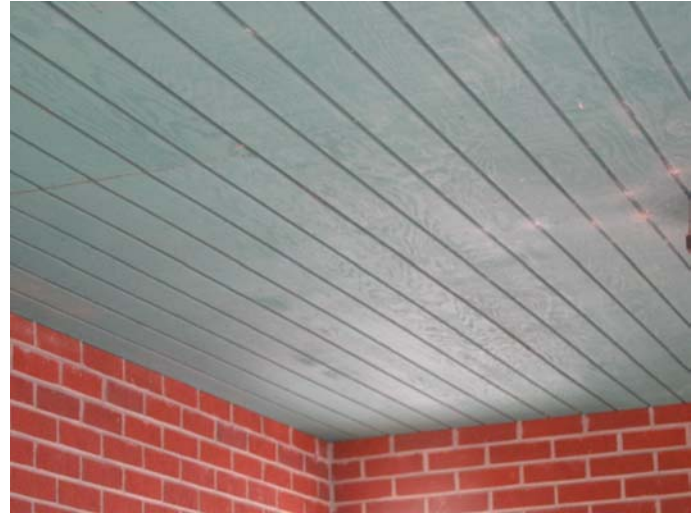
Comp #: 303 Wood Surfaces - Repair/Paint

The paint on all of the wood surfaces is dry and peeling. We suggest painting the mailbox structure and wood signs as soon as possible to protect the material from cracking, warping, and deteriorating. The association has reported this expense will be treated as a Reserve expense every 5 years. Repairs should be completed at the same time as part of prep work. In this environment, it is recommended that wood surfaces are painted at least every 4 - 5 years.

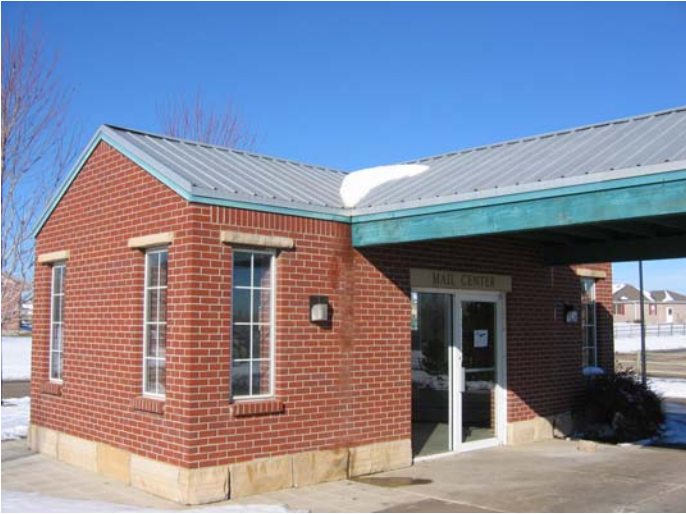
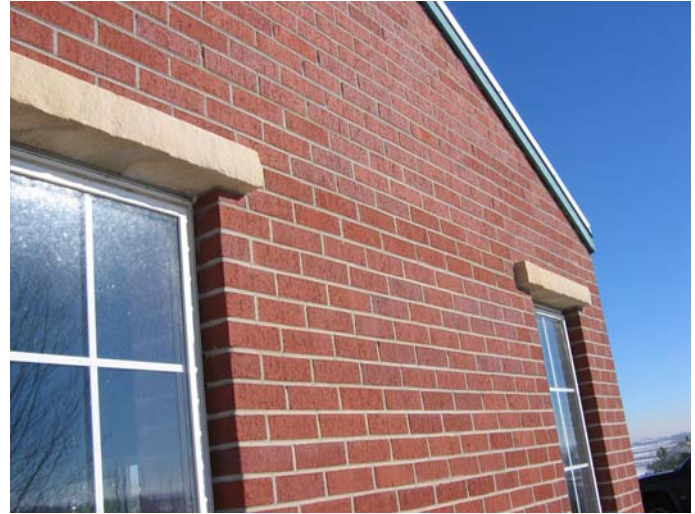
Comp #: 306 Brick - Replace

All brick surfaces were in good condition with no unusual problems noted. Brick materials have a very long life expectancy and replacement is unlikely. Therefore, no Reserve funding is required for replacement of this component.

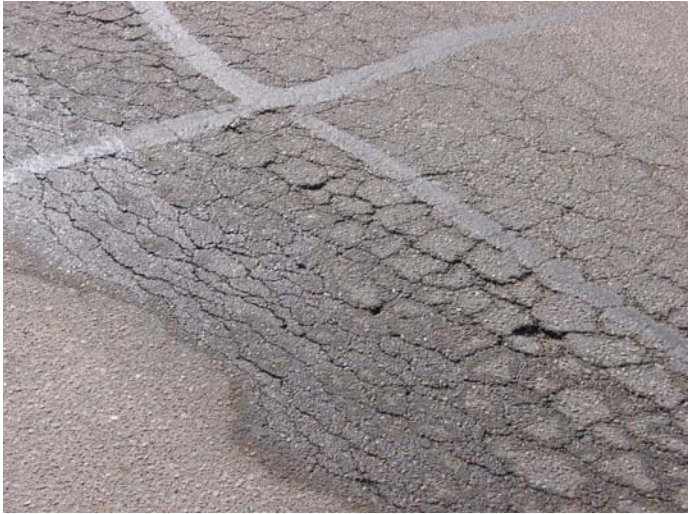
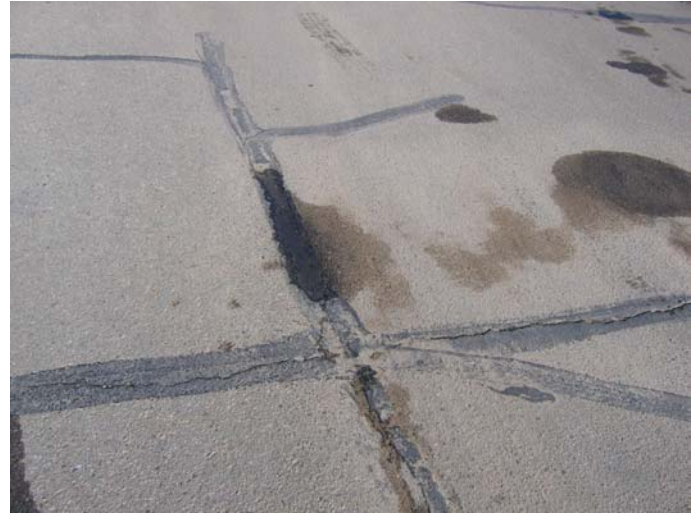
Comp #: 401 Asphalt - Overlay

Evidence of significant crack fill throughout entire community. In addition, there was some significant raveling at the south entrance drive. It was reported this area will be repaired in 2005. These streets were installed to a greater depth than required by Weld County, and a fly ash was used as a base material prior to installing the asphalt. While this quality of application may provide an extensive life expectancy, the asphalt still needs to be maintained and seal coated on a regular basis. With proper maintenance and based on the quality of the application, we estimate the resurfacing cycle to range between 20 - 25 years. The remaining life is based on the age of the surface and the current conditions.

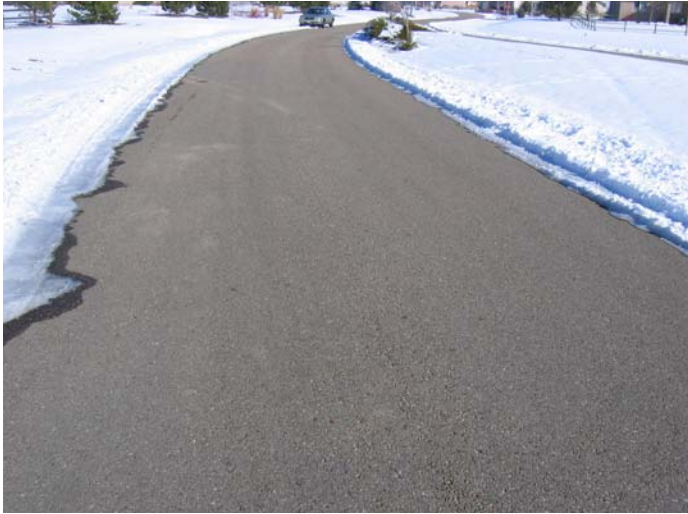
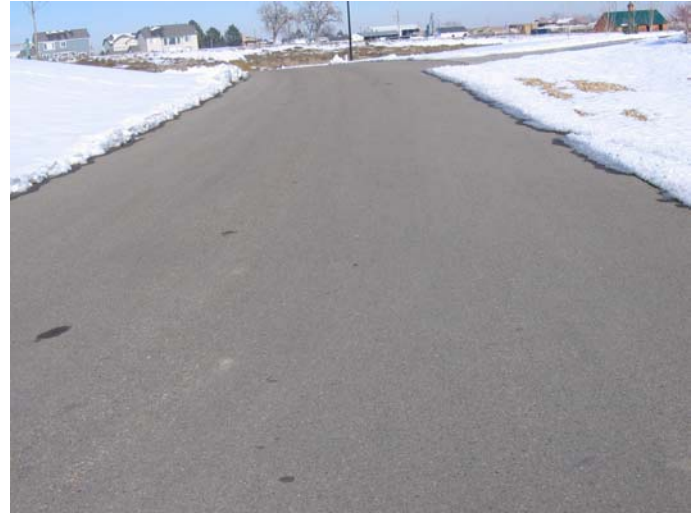
Comp #: 402 Asphalt - Seal Coat/crack fill

All streets are dry and in need of a seal coat. In this environment, seal coating is recommended at least every 2 - 3 years. The association has requested to seal coat 1/3rd of the area every other year. This would put the sections on a 6 year cycle, which is too long for this environment. We suggest seal coating 1/3rd of the area every year, or the entire area every 3 years. Factors that influence the timing of seal coating includes level of traffic, weather (snow, rain, etc.), and the quality of past applications. In between seal cycles, we recommend crack filling and making repairs as needed with general maintenance funds. Based on condition, we suggest seal coating all surfaces after the winter season.

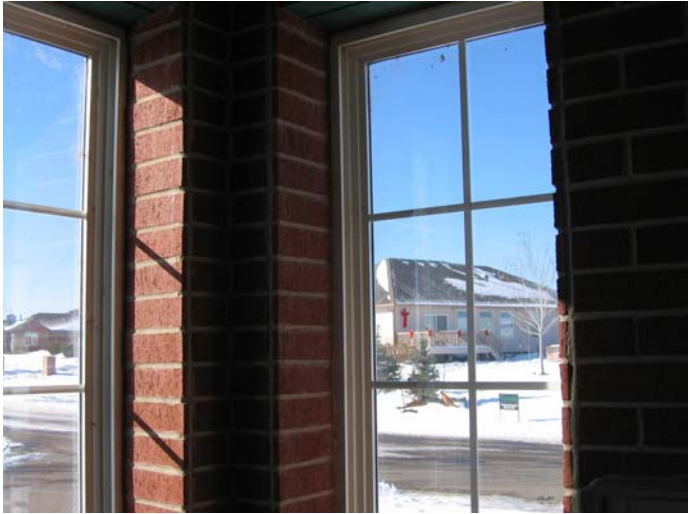
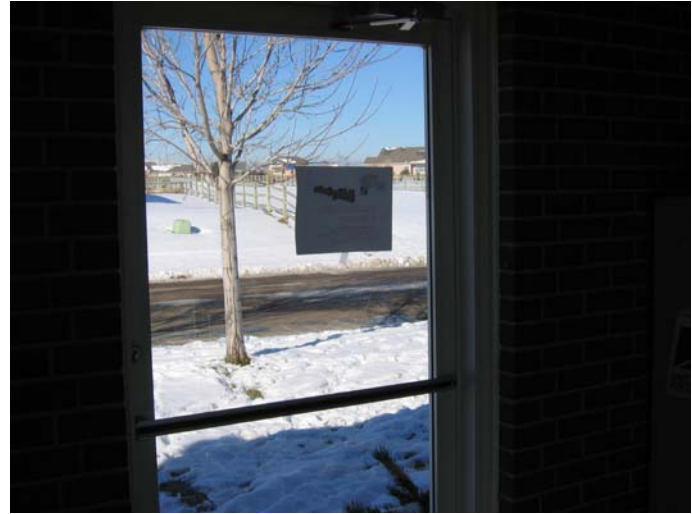
Comp #: 506 Windows - Replace

No current problems with broken windows. While these windows do not protect a living or habitable space, over a period of time, the windows will need to be replaced. This typically occurs every 25 - 30 years. The remaining life is based on age and current conditions. If windows are vandalized, then replacement should occur immediately with general operating funds.

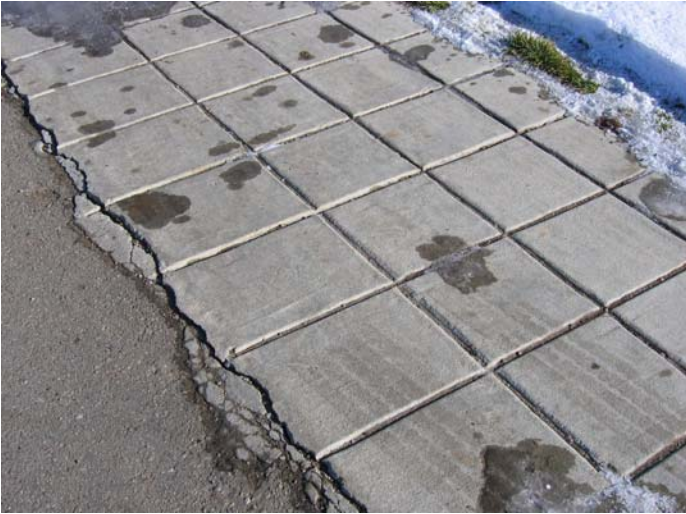
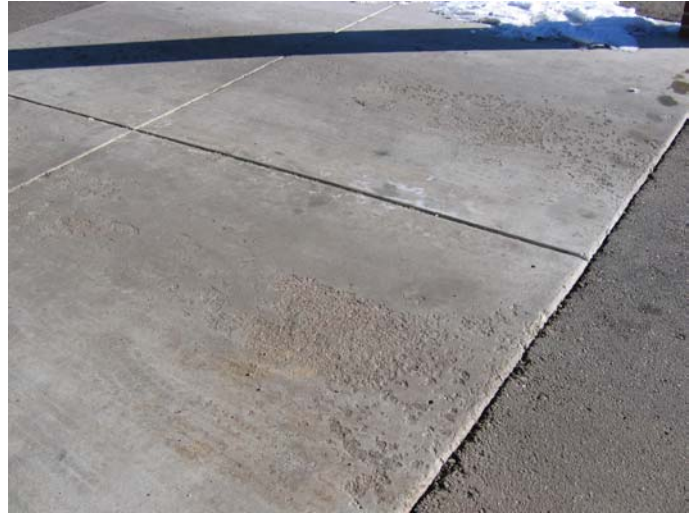
Comp #: 601 Concrete Surfaces - Repair

The drive area is beginning to show signs of spalling and minor cracking. The walkway area is in good condition with no major problems noted, other than a few cracks. Concrete surfaces are subject to gradual deterioration in these elements. It is unlikely that all concrete surfaces will need to be replaced at the same time. It was reported by the client that repairs will occur on an as needed basis with general operating funds. Therefore, no Reserve funding is required for this component.

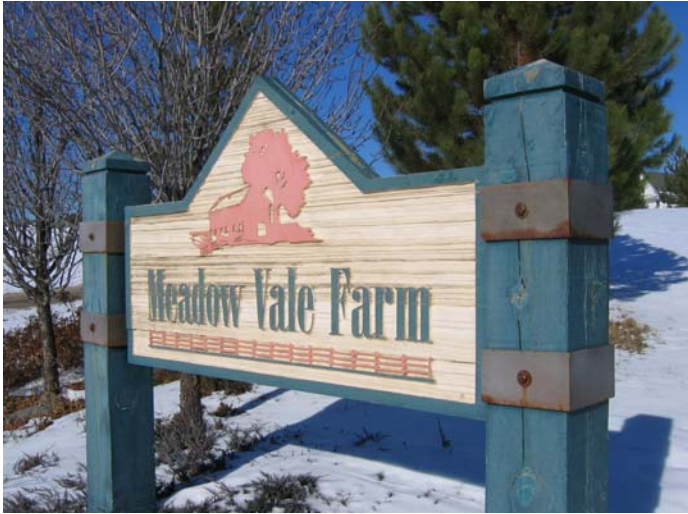
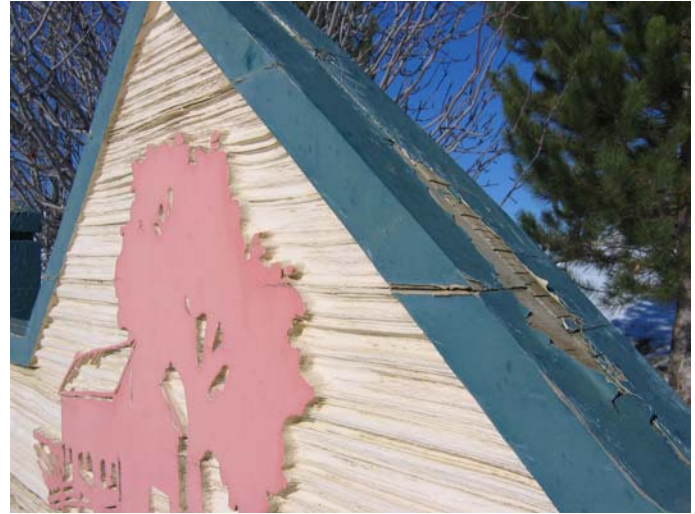
Comp #: 801 Monument Sign - Replace

The signs has a general worn appearance with faded and peeling paint, along with some cracked and split materials. The painting can be done as a maintenance issue to improve the overall appearance. Wood signs typically need to be replaced every 10 - 15 years, depending on the level of maintenance and quality of the materials. The estimated replacement cost is for a sign of similar design and materials. If the association decides to upgrade materials, a higher replacement cost should be anticipated.

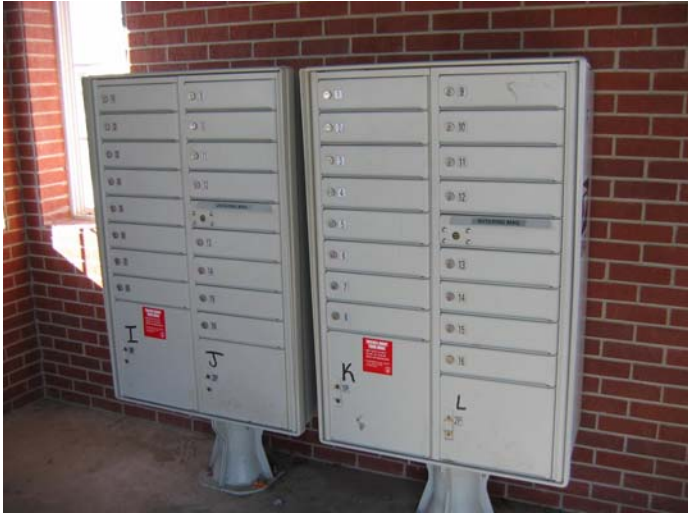
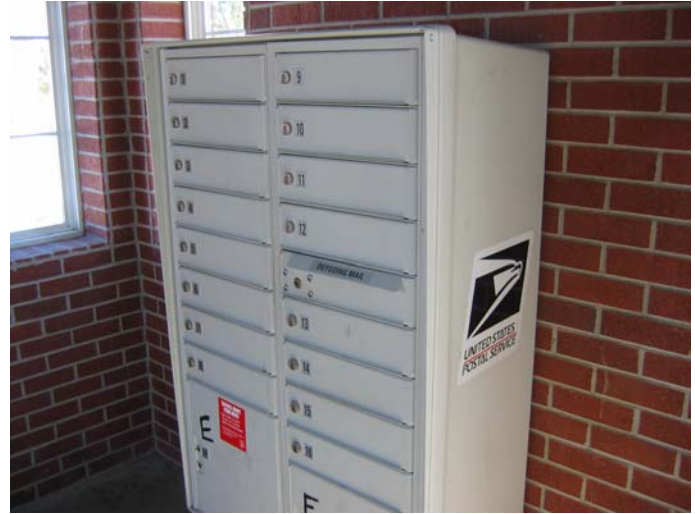
Comp #: 803 Mailboxes - Replace

These mailboxes are located inside a room and are protected from the elements. During our research, the USPS reported the association is responsible for replacement of these CBU's (cluster box units) when necessary. It was reported they used to replace these, but this no longer applies to this jurisdiction. However, the association reported the USPS said they will replace since they were the ones that initially installed the boxes. Therefore, per the clients request, we have not included Reserve funding for these boxes. If the association were to be responsible for replacement, expect to replace every 20 years at a cost of approximately \$9,000.

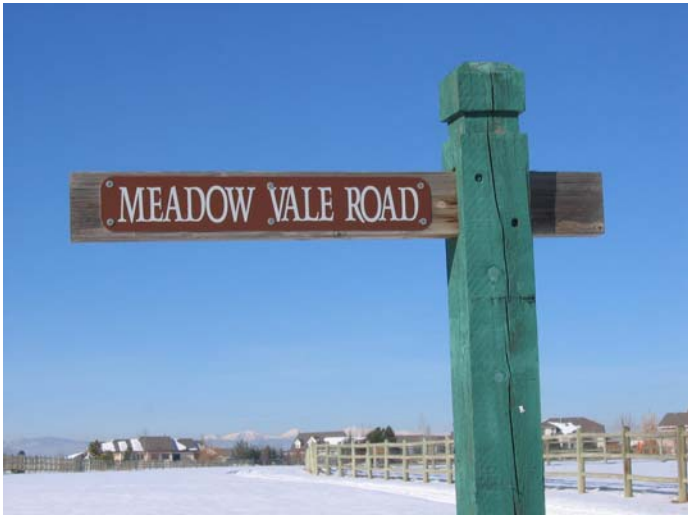
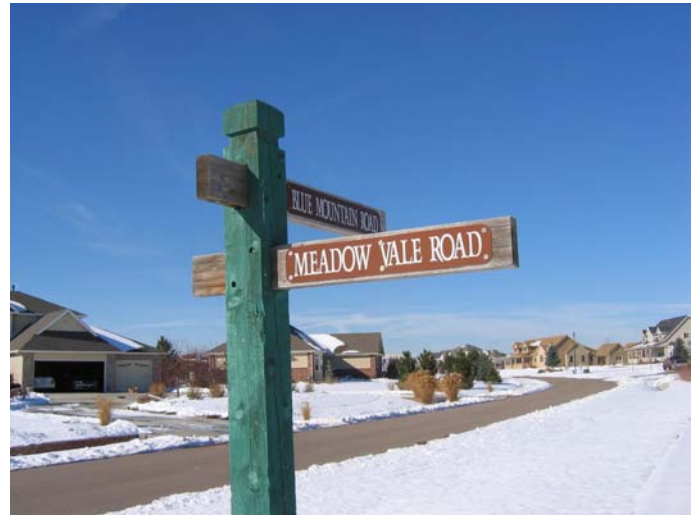
Comp #: 808 Street Signs - Replace

In general, the signs are legible and sturdy, but some of the posts are beginning to split. Similar to the monument sign, the wood should be stained or painted to protect the material from deterioration. In order to maintain a consistent appearance throughout the property, we suggest planning on replacement at the same time as the entrance monument sign. By having the same contractor perform the work, this will also keep the replacement cost to a reasonable amount. If upgraded materials are used during replacement, then the useful life can be adjusted in future Reserve Study updates.

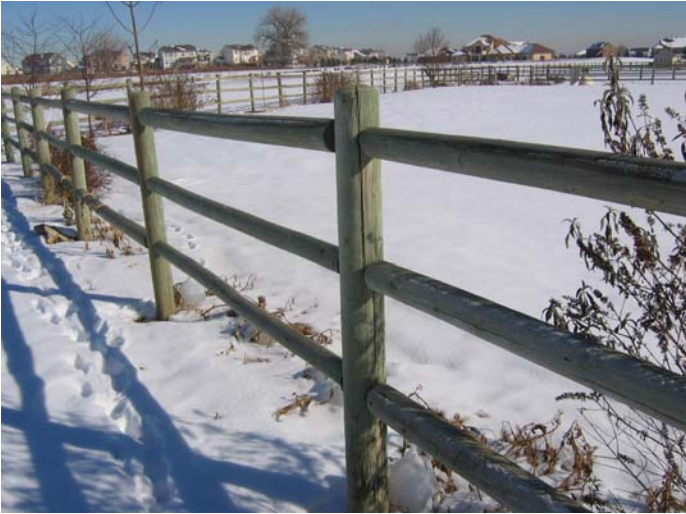
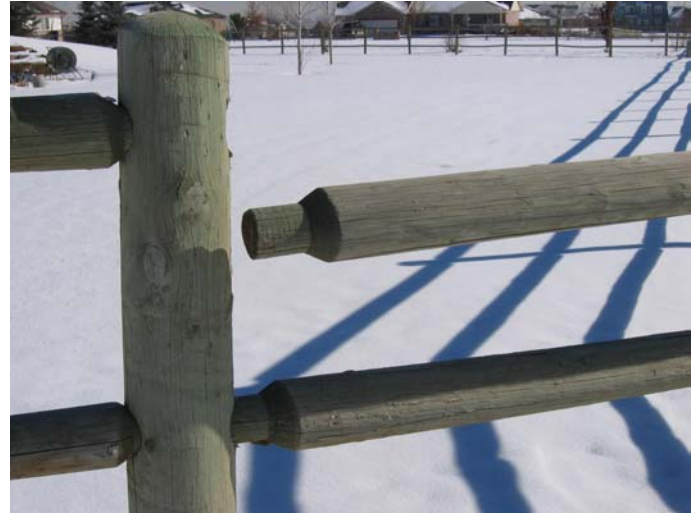
Comp #: 1009 Rail Fencing - Replace

Conditions vary throughout community, but the majority of the fence is in good condition and the areas that were tested were stable and intact. A few rails were either broken or had slipped out of the support posts. There was one post that had broken at the base, causing the rails to fall to the ground. The client reported annual repairs will be budgeted in the operating account. However, complete replacement should be anticipated every 20 - 25 years. The remaining life is based on the observed condition of the fence throughout the property. At unit #2250, about 260 LF was recently installed and is new.

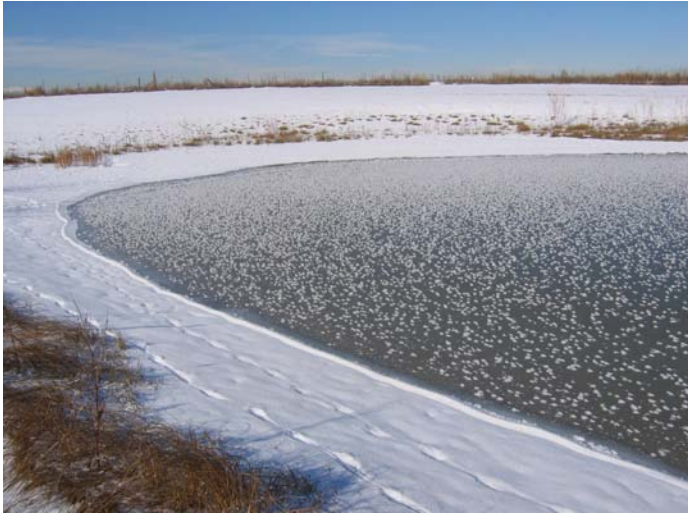
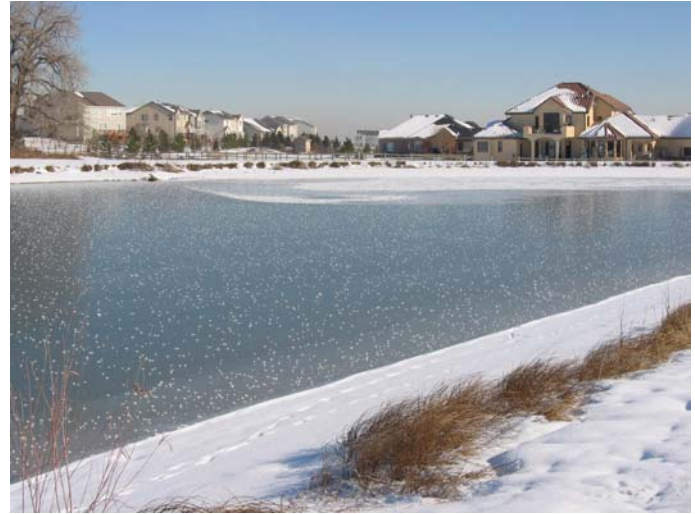
Comp #: 1704 Irrigation Supply Pond - Renovate

Before pond was developed and filled, it was treated with fly ash to prevent seepage into the soils. It is filled from natural sources that is provided to the association from the Oligarchy Ditch Company. According to the company that designed the system, this pond should have an indefinite life expectancy and should not require any major maintenance. Occasionally, it may need to be dredged to accommodate the correct amount of water, but there are too many factors to determine the frequency of this and how much it would cost at the time. It is recommended that this maintenance is treated as a separate issue from the Reserve account.

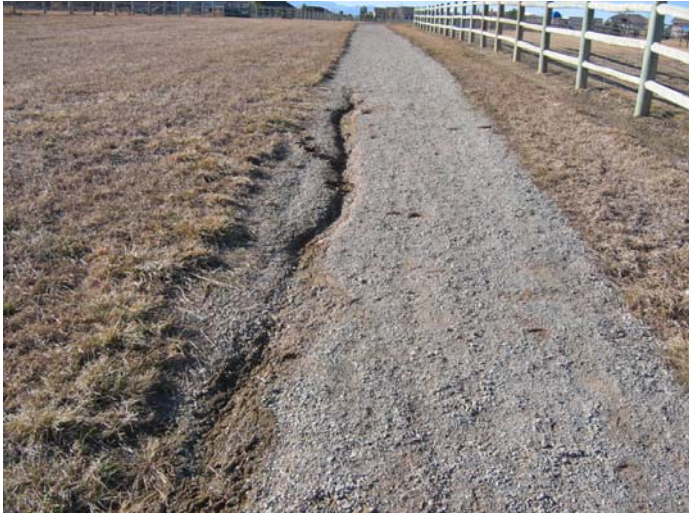
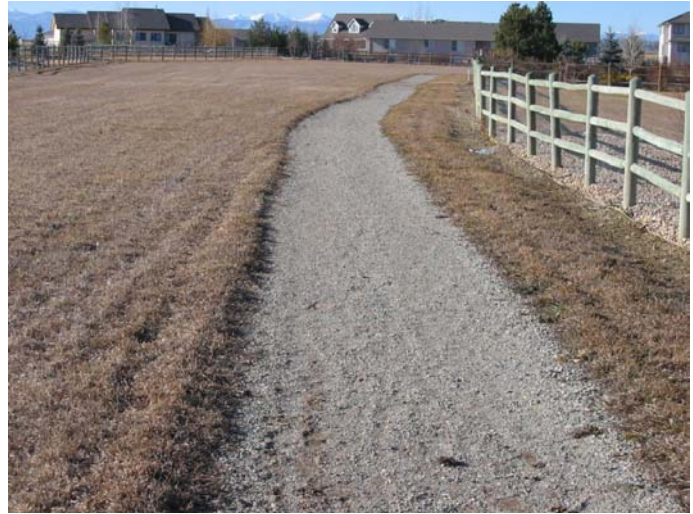
Comp #: 1806 Crushed Gravel Paths - Replenish

After the draft report was sent out, we were able to go by the property and re-inspect the condition of the pathways. There was some evidence of a few washouts and loss of gravel throughout the pathways. Typically, replenishment of gravel occurs on an as needed basis with general operating funds. However, the association has requested we include a line item to replenish the pathways every 10 years. Based on the observed conditions, we anticipate next replenishment will occur in about 5 years.
